Inspection Report

Complete Building Inspection Services

19 Ocean Beach Drive, Shellharbour, NSW, 2529

Pest And Building Inspection

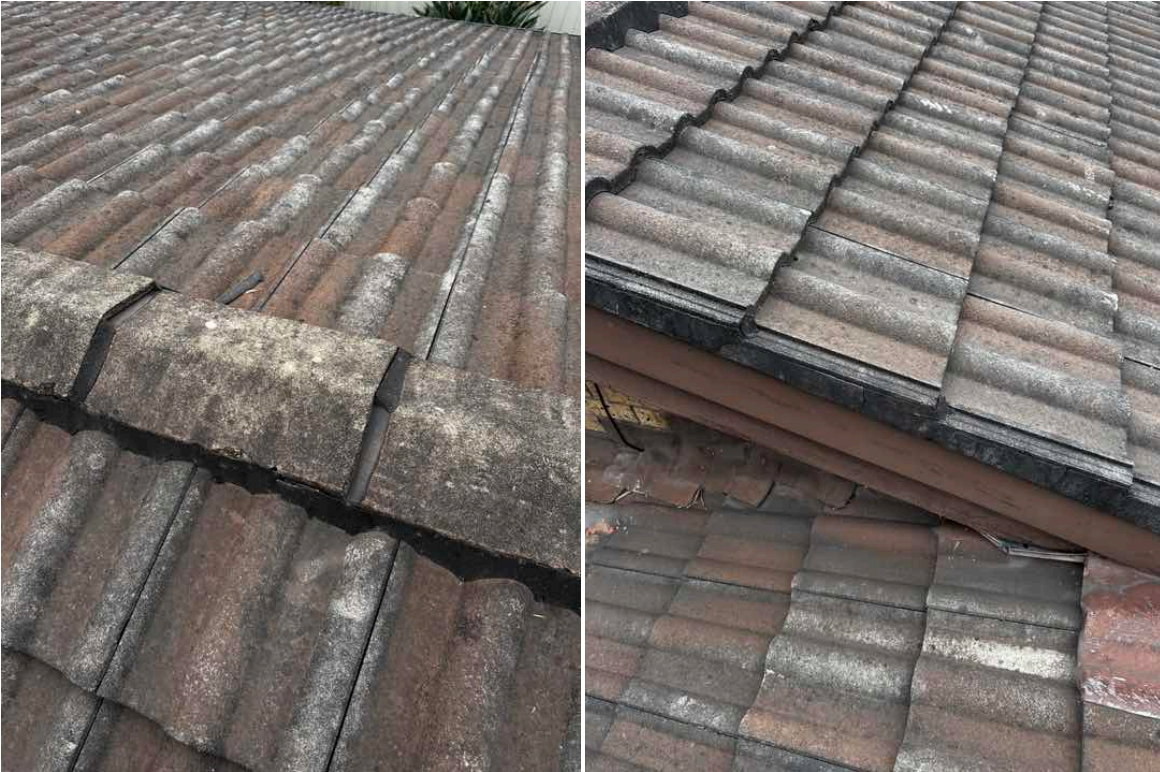
Roof Clad Condition

Mortar cracks visible. Whilst common on properties of this age we recommend having repaired as it may result in water ingress into the roof cavity

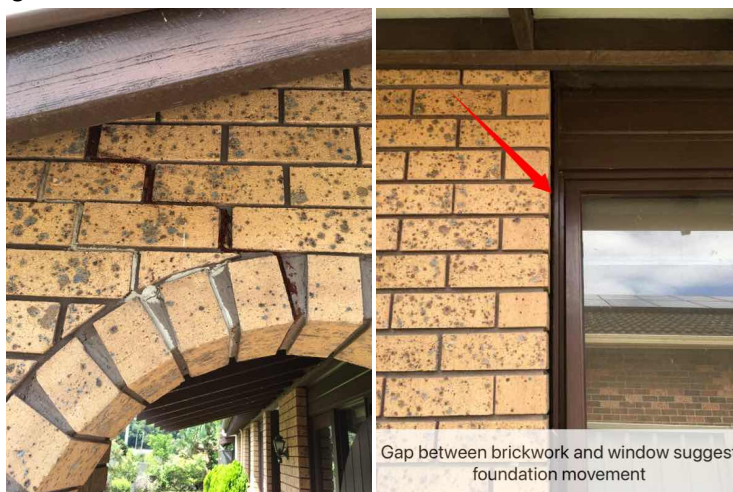
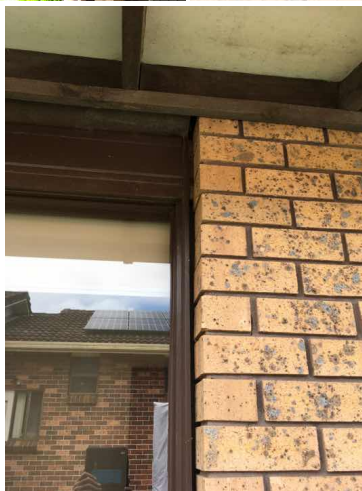
External Brickwork

General settlement/movement/cracking to sub-floor brickwork maybe associated with age, reactive nature of clay foundation material &/or site drainage issues associated with site topography. Undertake any general maintenance/repair to include replace damaged bricks & improve site drainage as necessary. Note: Observe settlement/movement/cracking for any significant variation & reassess/investigate further and/or seek further advice from a structural engineer.

Gap between brickwork and window suggest foundation movement

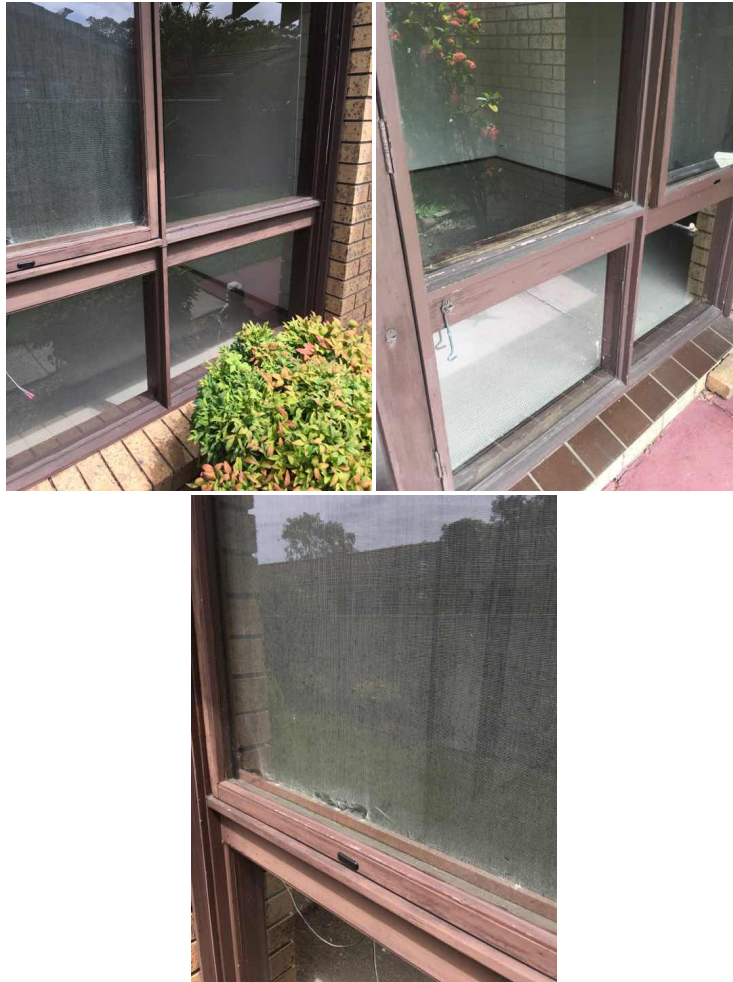
Overall Condition

Sections of the external windows have paint deterioration and weathering to timbers noted. Undertake external paint program to all windows to include all required surface preparations and repairs etc to protect timbers and prolong the lifespan of materials.

General age related wear and tear/damage to fly screens apparent. Engage contractor to repair/replace fly screens

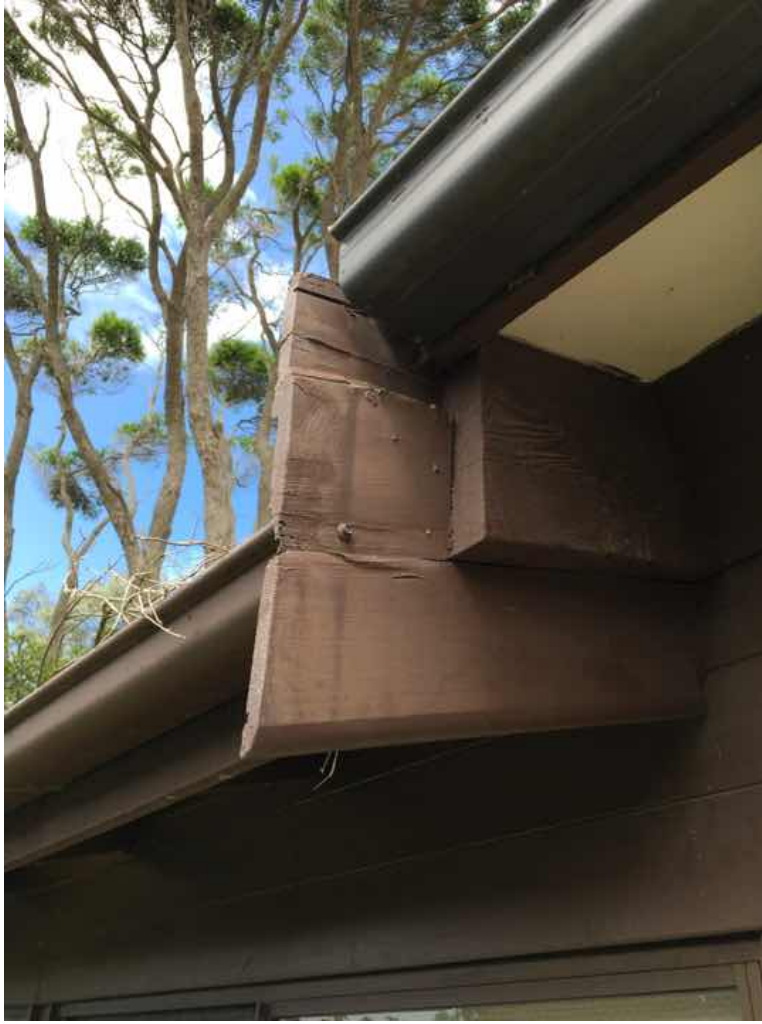
Condition

Paint / finish was deteriorated in areas and is in need of maintenance - Sanding back affected areas and painting required.

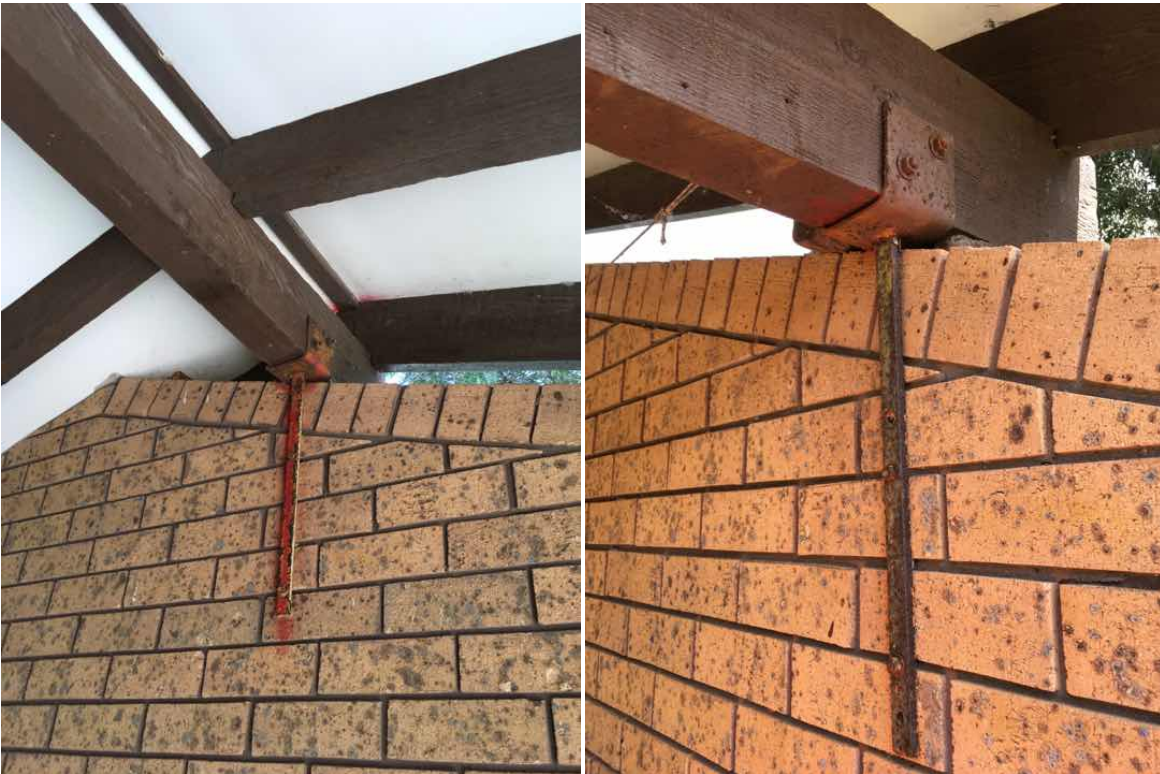
Frame Findings

Corrosion to carport steel brackets. Repairs required to include removal of excess rust, Treat, seal and repaint affected sections with a rust inhibiting paint. Note without repairs corrosion will continue and may affected the integrity of the carport.

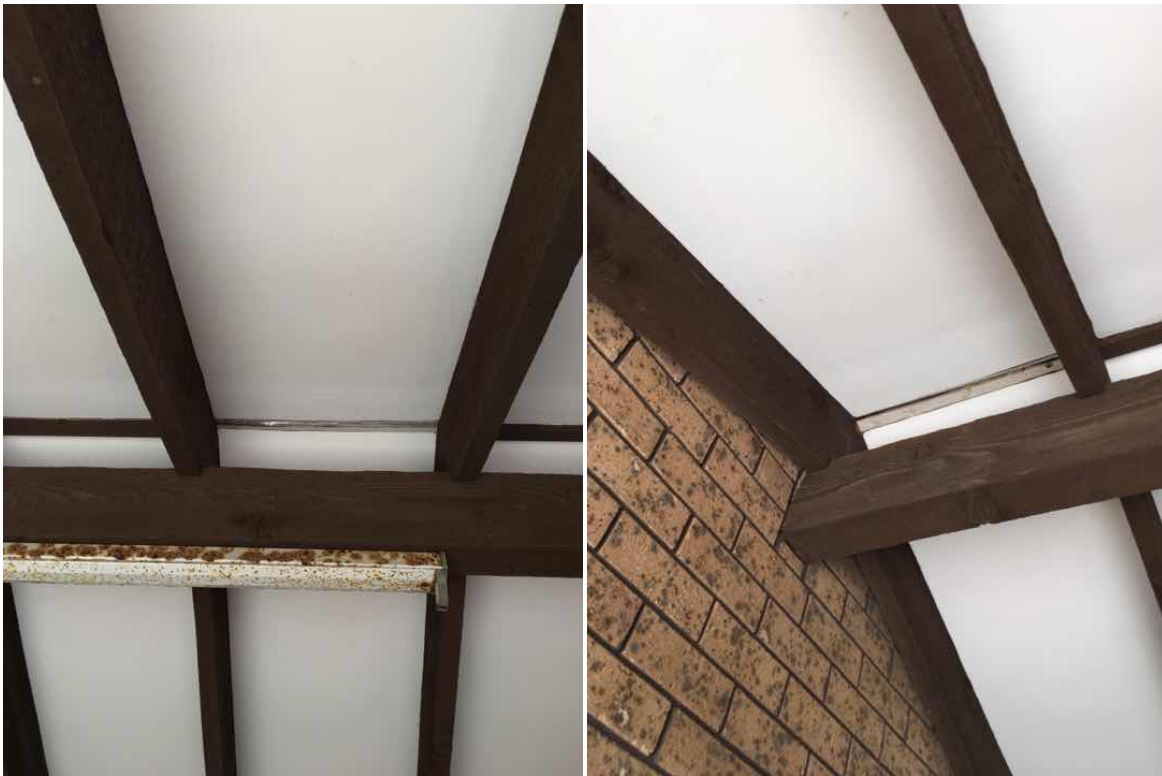
Roof Findings

Missing trims to ceiling sheets of carport noted. Undertake repairs or replacement of same as required.

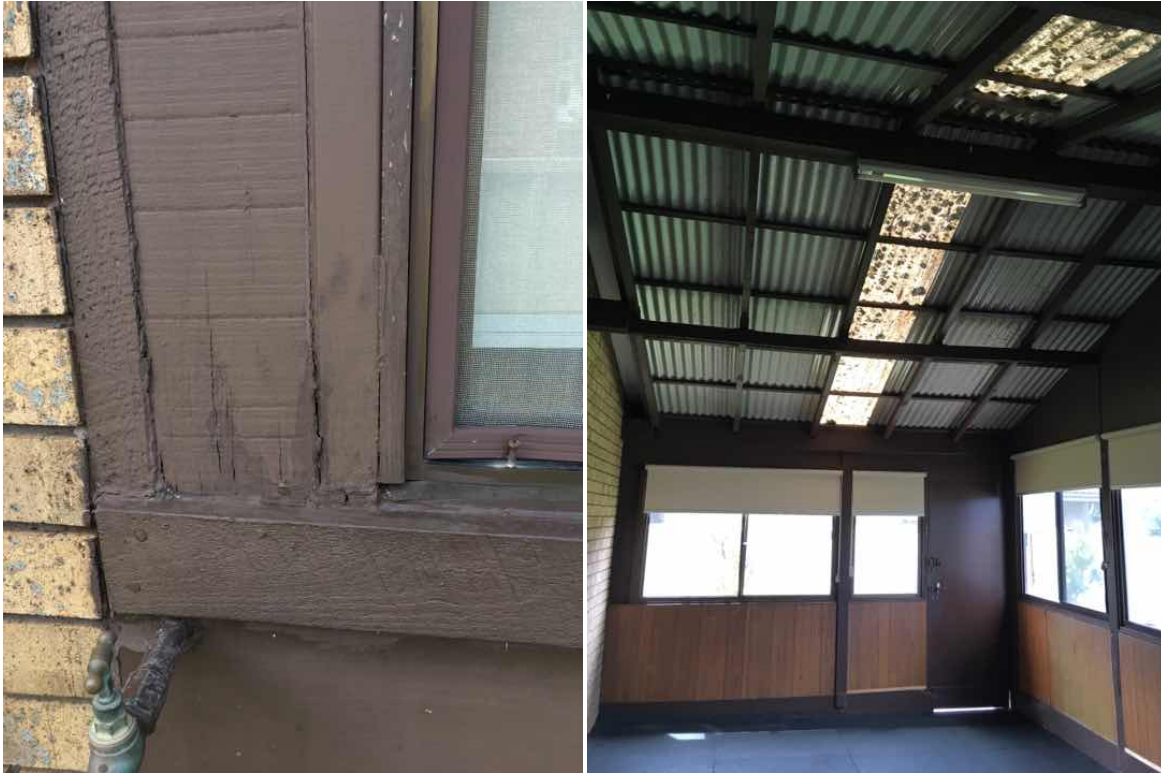
Pergola Framework

Timber fungal decay to the timber trims visible. Recommendations: undertake repairs or replacement to affected Timbers as required

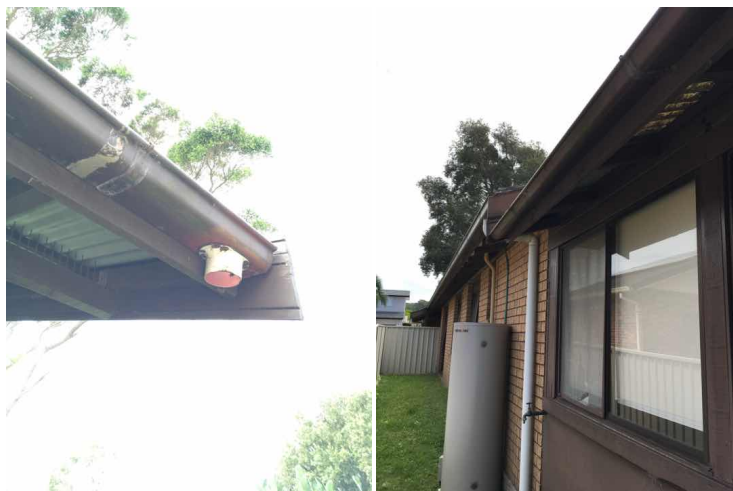
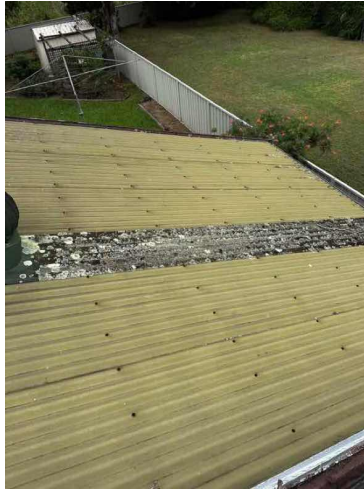
Pergola Roofing

Alsanite roofing shows deterioration associated with UV exposure & appears in an aged condition. Upgrade/replacement of same to include installation of adequate flashings is anticipated.

No down pipe/s fitted or connected to storm water discharge - Uncontrolled stormwater discharge has the potential to cause differential settlement to the footings, cause rising damp and is also conducive to termite infestation. Recommendations: Install down pipes to include connection to site stormwater drainage.

We note loose/sagging sections of guttering associated with inadequate fixings or spacing of brackets etc. Refit same and improve fall to guttering is recommended.

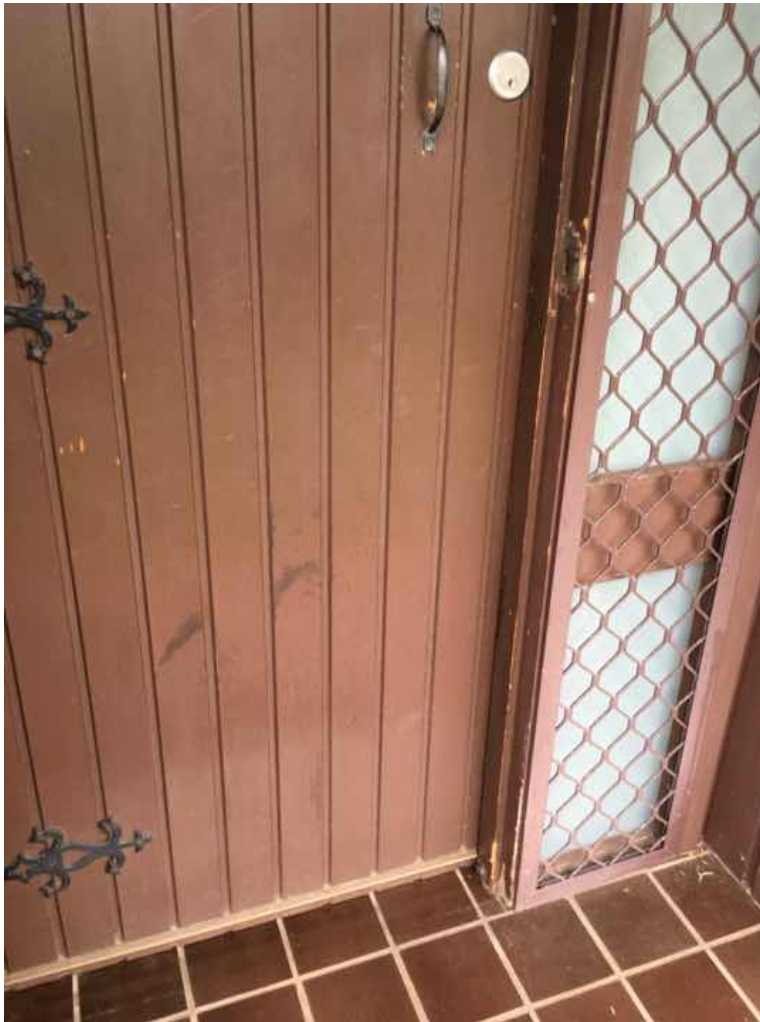
Weathering to external surface of timber door noted. Engage painter to sand and repaint door to prolong the lifespan of materials etc

Front entry door requires general maintenance to include ease and adjust hinges and/or trims door edges etc as required.

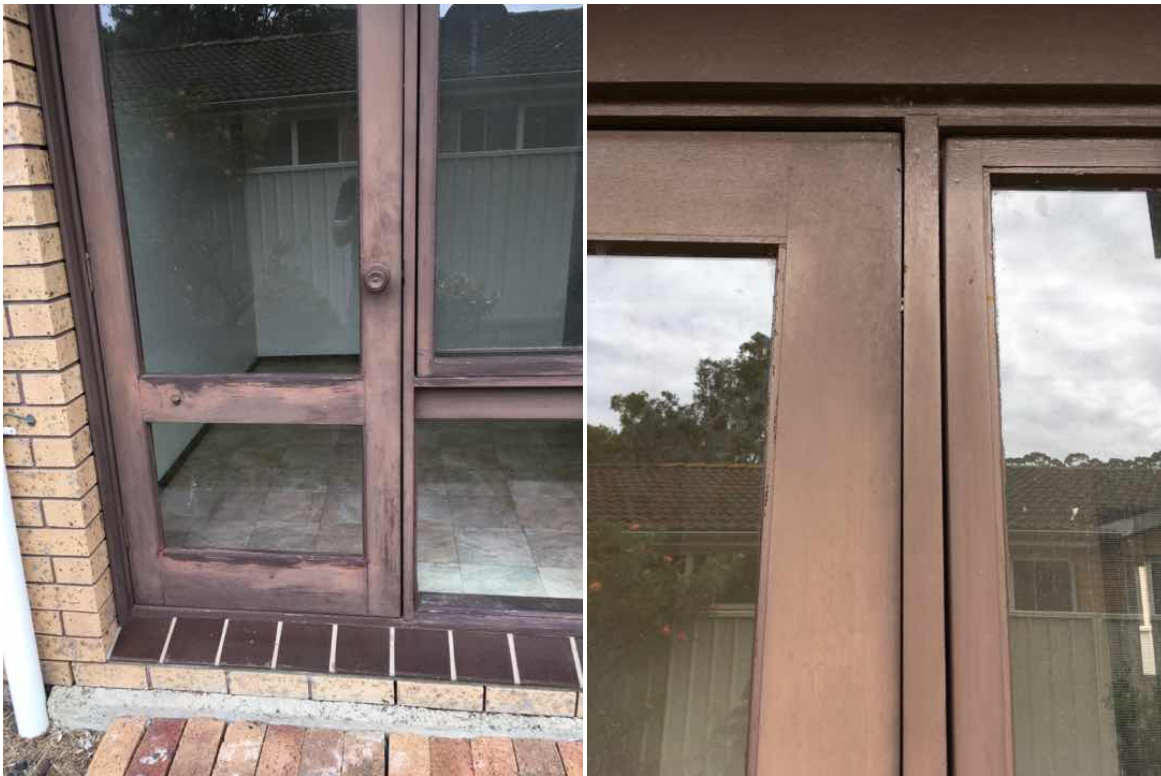
Other Doors

Weathering to external rear/laundry access door, noted. Undertake repairs/maintenance etc to same. We recommend replacement with external grade door to be considered.

Undertake general maintenance to rear external access door to include ease and adjust etc as required.

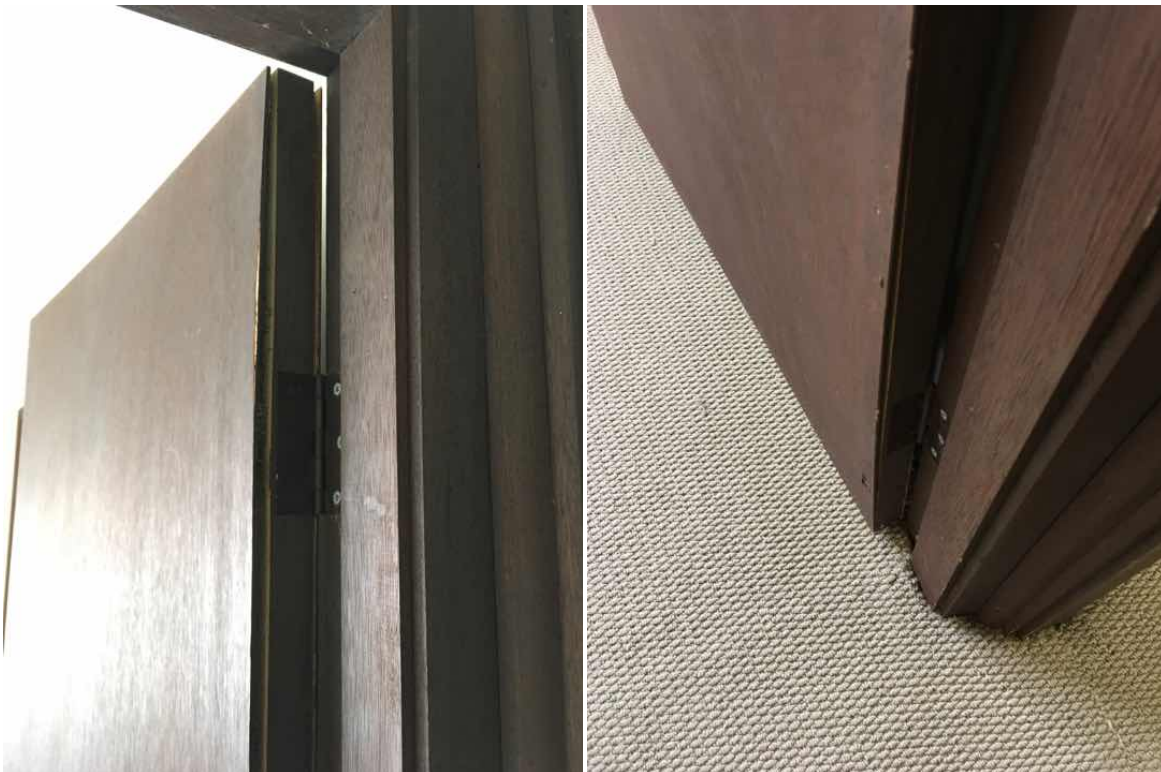
Door

Delamination of individual timber door panels noted. Replacement of same is recommended as the most affective improvement option.

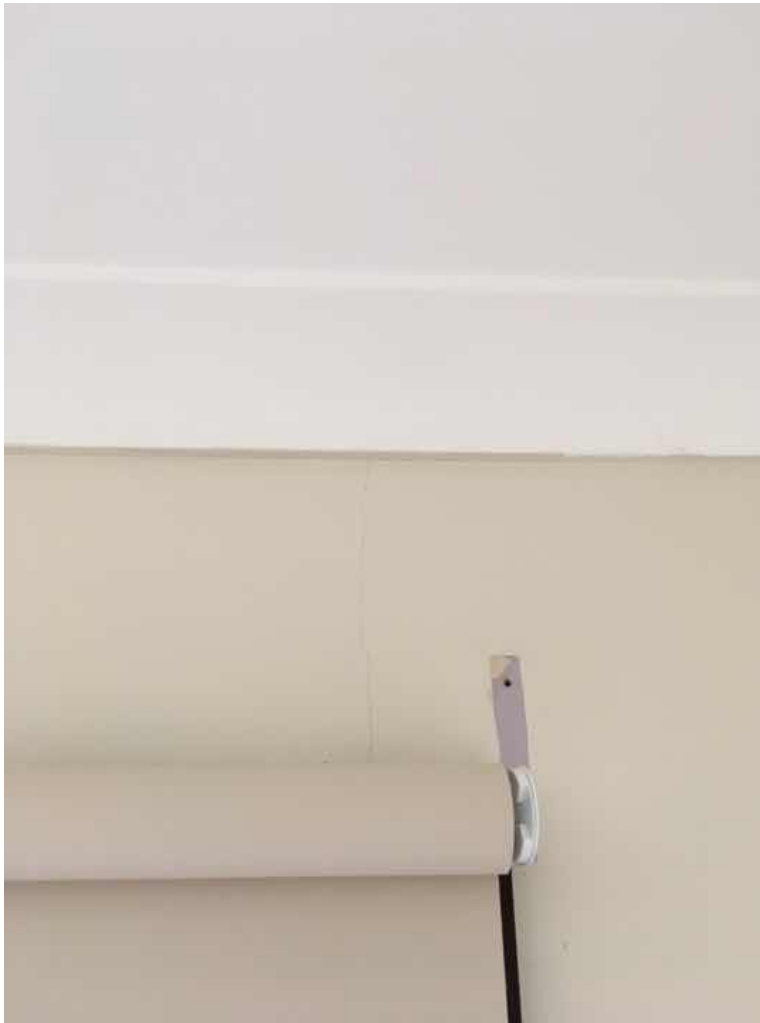
General ageing, settlement cracking and/or denting and/or wear and/or previous patching and the like is evident on ceiling linings - Recommendations: All surface marks/damage and settlement cracks/crazing etc to linings/joints/cornices should, with adequate surface preparation & maintenance/repairs/refixing, allow satisfactory redecoration/touch-up

General ageing and/or denting and/or wear and/or previous wall patching and the like is evident on wall linings - Recommendations: All surface marks/damage, blistering paint, popped nails, sagging linings and settlement cracks/crazing etc to linings/joints should, with adequate surface preparation & maintenance/repairs, allow satisfactory redecoration/touch-up

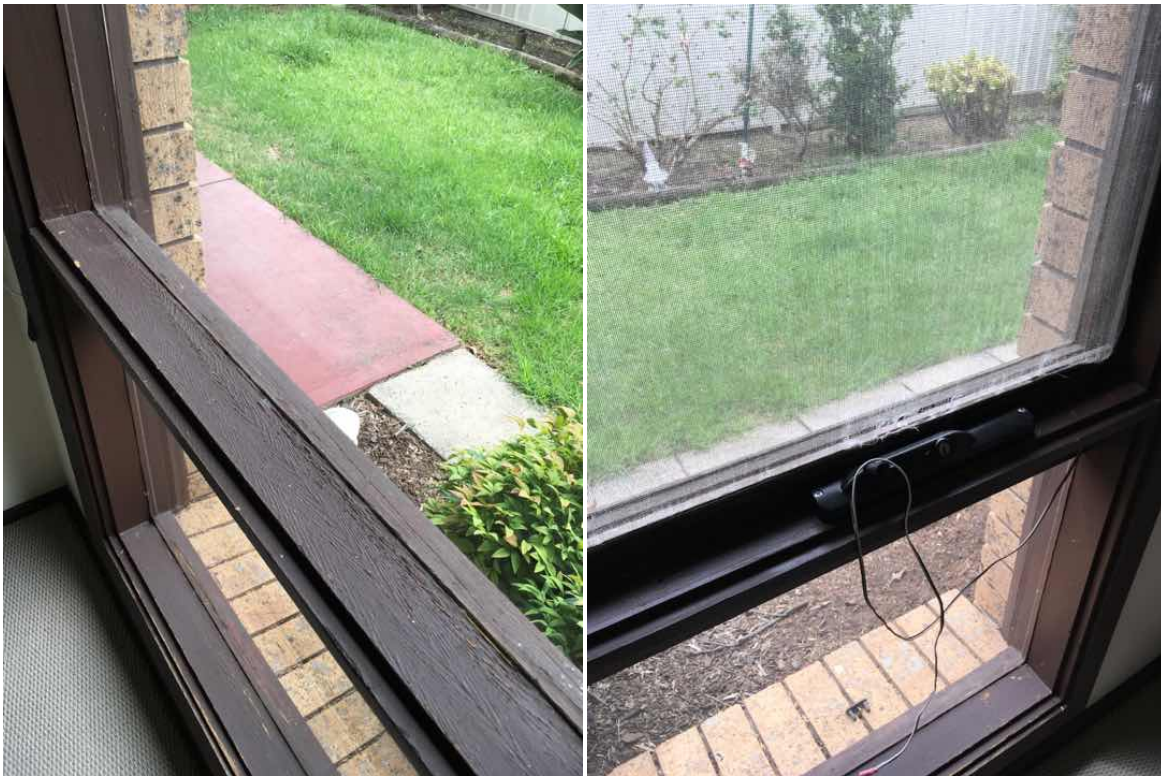
Windows

Undertake general/age related maintenance to timber windows to include ease and adjust/replace chain winders, sash cords/springs/rollers and paint renovations etc. Note: Monitor windows during periods of heavy/prolonged rain and reseal if/as required.

Weathering and sun damage to timber window sills noted. Sand back same and repaint as required

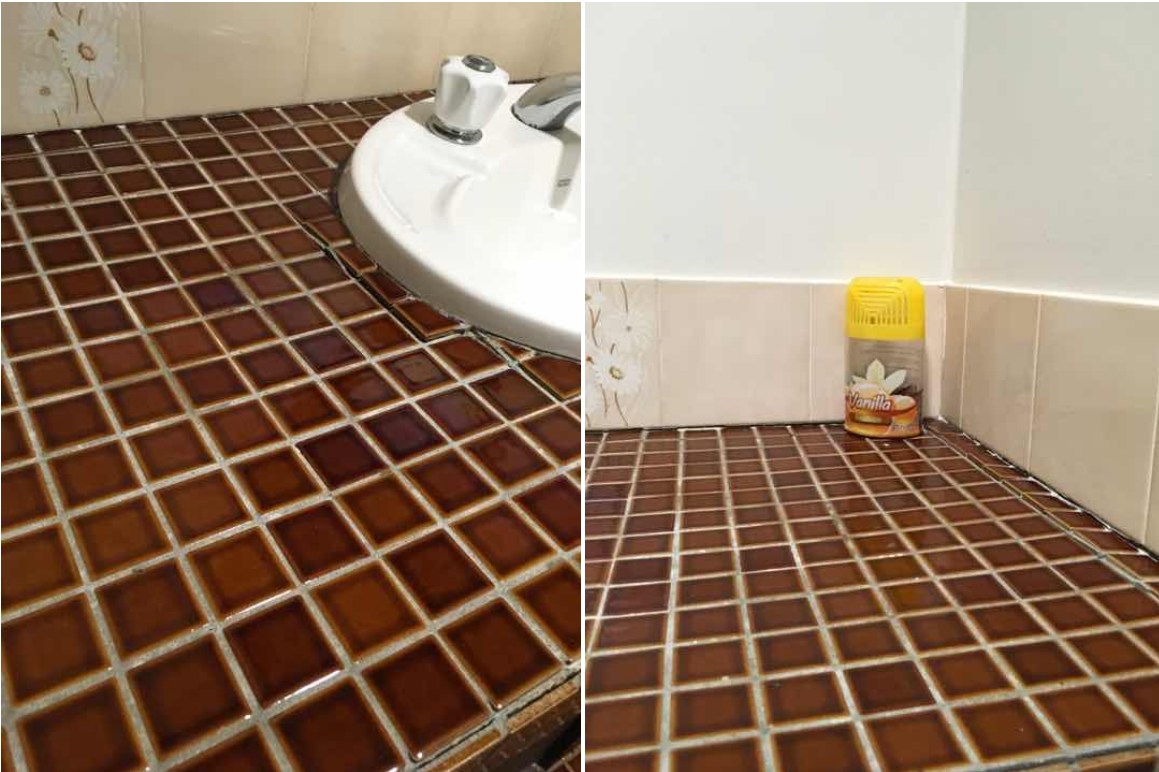
Sink

General deterioration and wear to sink, cupboards and water damage of benches. Replacement recommended.

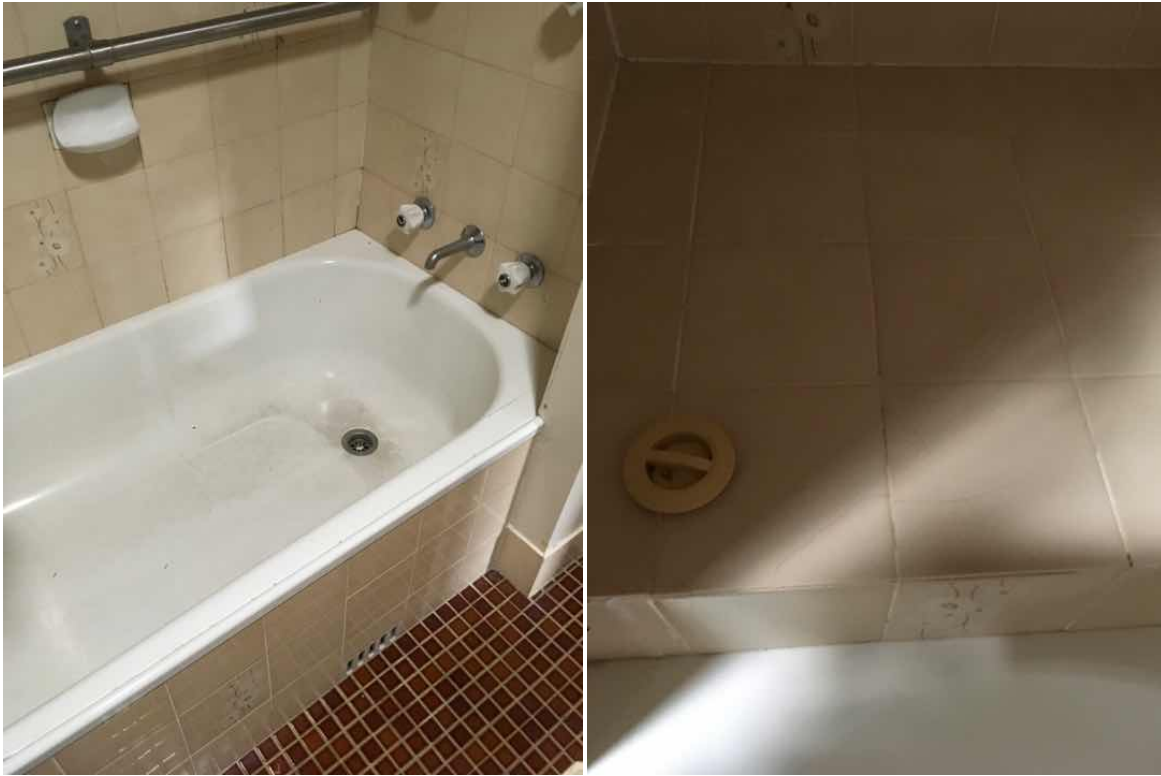
Bath

Age related wear and tear to bath surface noted. Re-surfacing bath maybe considered a suitable method of repair. Maintain silicone to bath hob/edges and splash zone to prevent any future water leaks as required.

Hair line cracks in tile/s noted to bath hob. This can cause extensive floor and floor frame damage and is conducive to termite infestation if water should begin to leak through into the cavity. Undertake short term maintenance to include regrout and seal tiles etc to prevent any potential water ingress. Future replacement by a qualified tiler is recommended

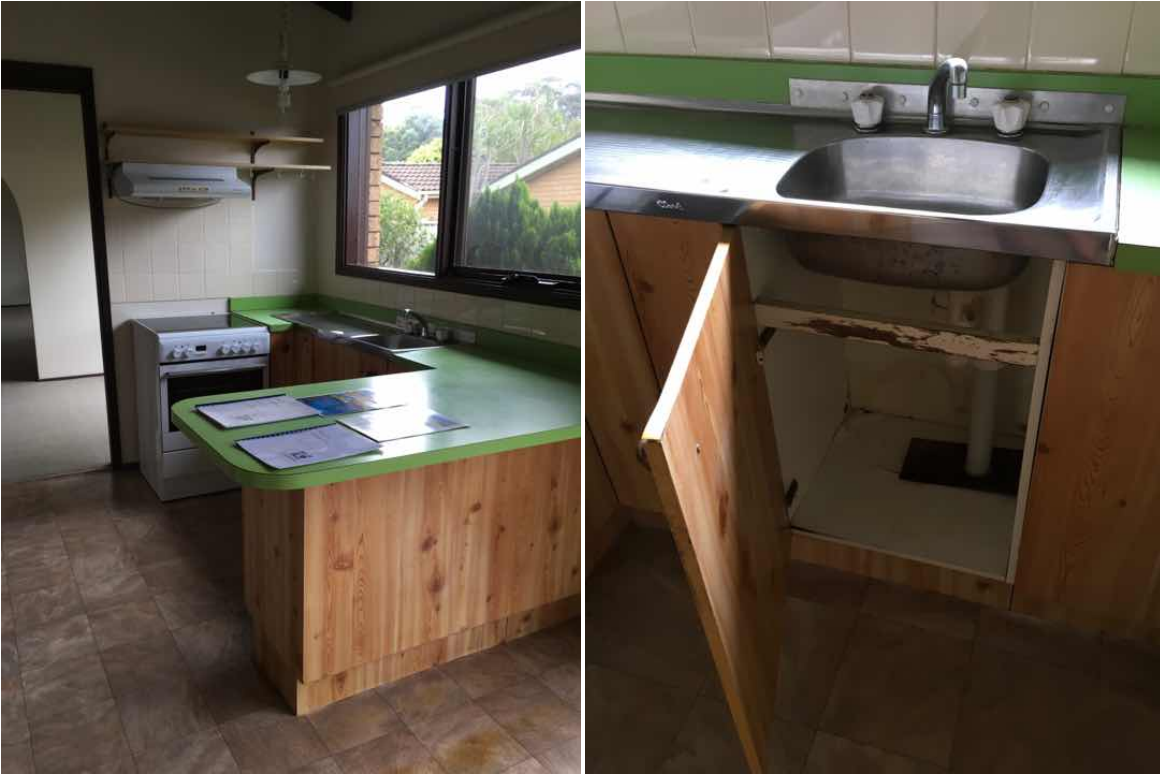
General age/damage has occurred to kitchen and components. Recommendations: Upgrade and renovation to the kitchen areas is recommended as the most affective and economical long-term Improvement option.

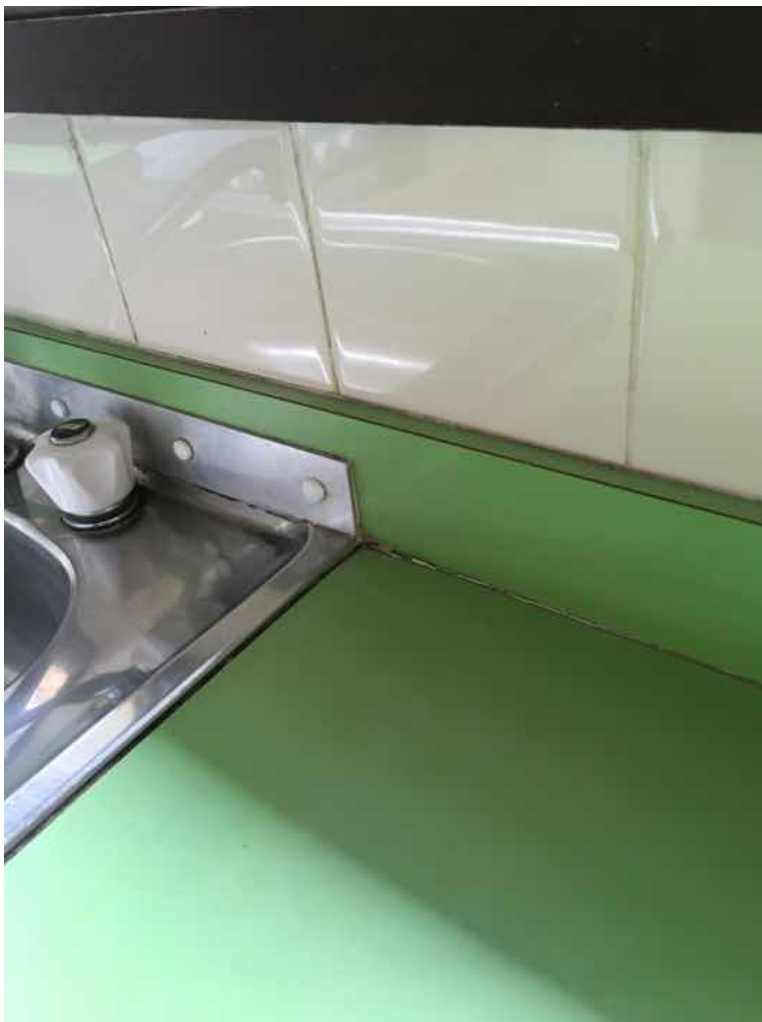
Sink and Taps

Bench top and splash back junction sealing deteriorated - Recommendations: Re-sealing by a plumber or general maintenance contractor is recommended to prevent water access behind the bench.

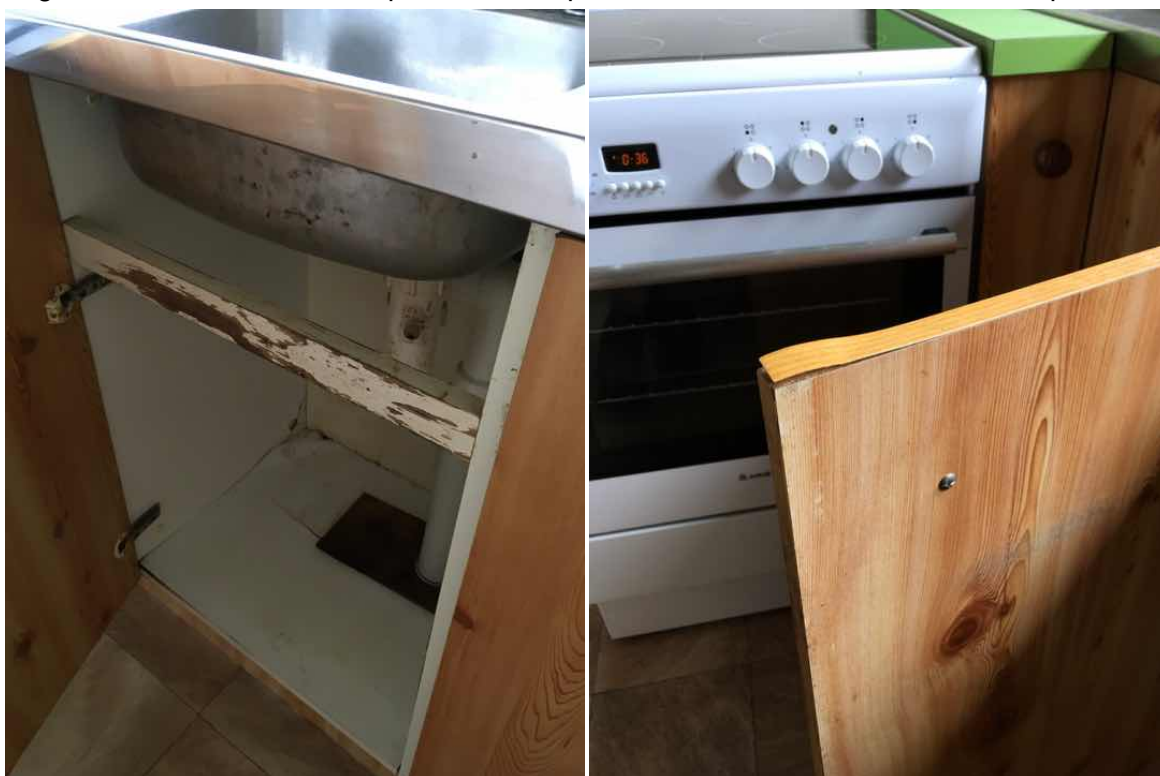
Cupboards And Bench Tops

Water damage to cabinet observed. Replacement required. Contact a cabinet maker for repairs.

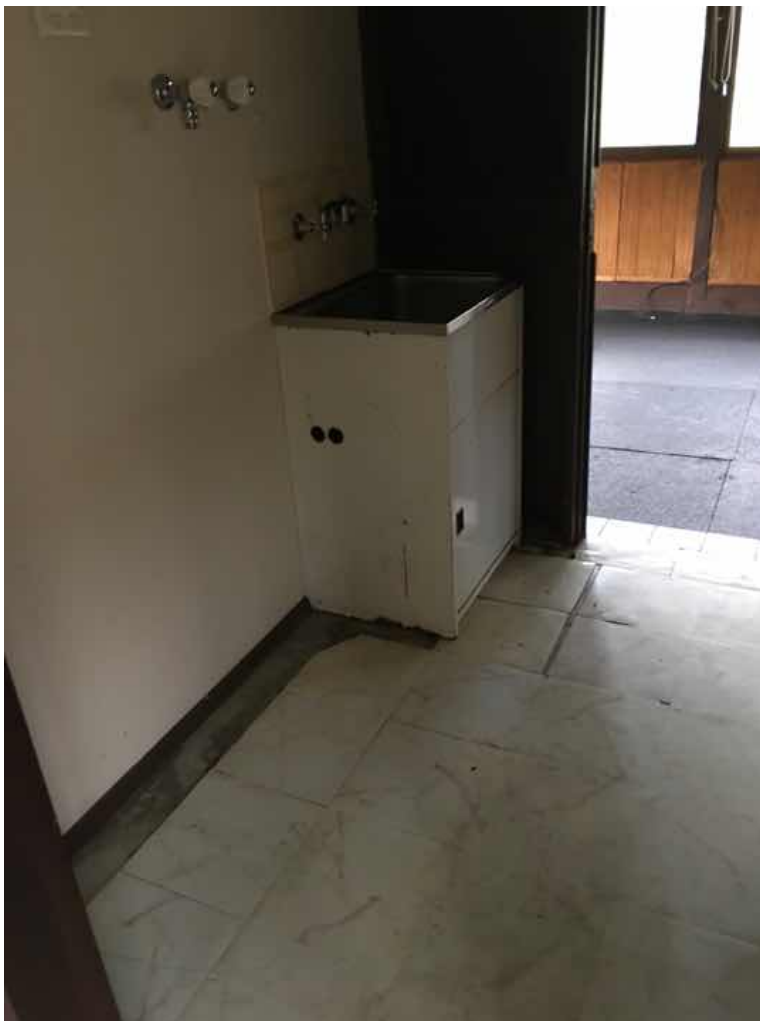
It is most likely original fibro linings will contain asbestos. Undertake any cosmetic maintenance/repairs to linings if/as required. Note: Asbestos cement products have been removed from the market due to their link with health disorders. Concerns with the product appear to exist only when asbestos sheeting is ruptured and the asbestos fibres disturbed.

Laundry appears in a poor condition and will require repairs in the short term. Future upgrade and renovation is anticipated.

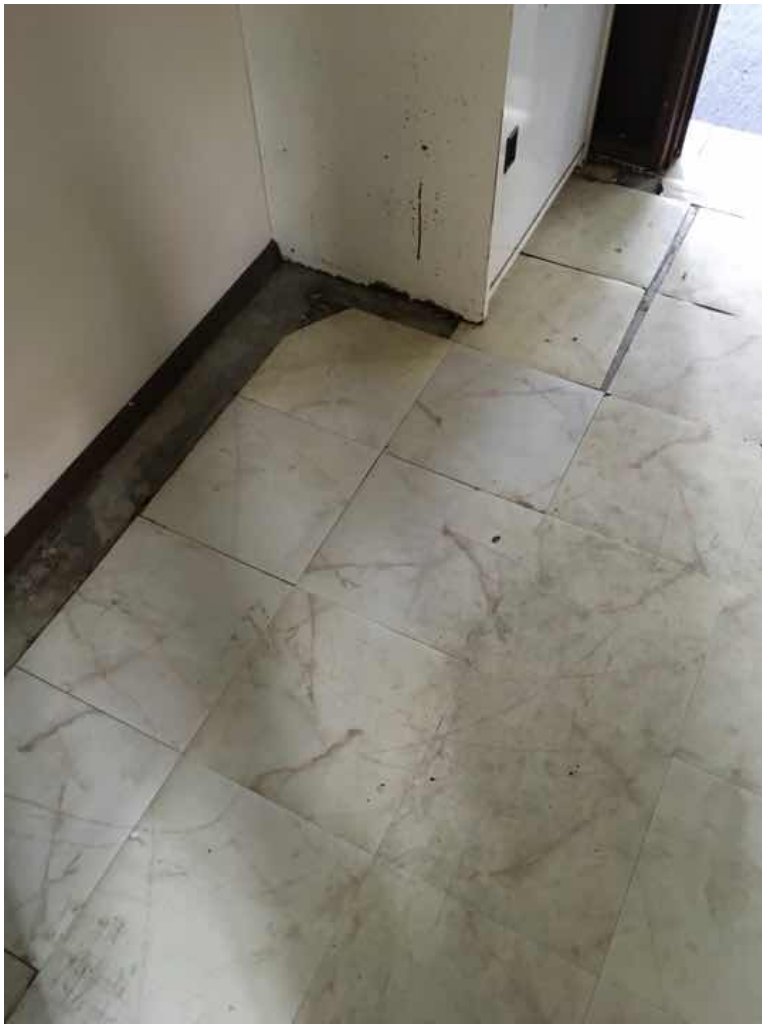
Flooring

Lino deterioration visible in laundry floor - Recommendations: Replace.

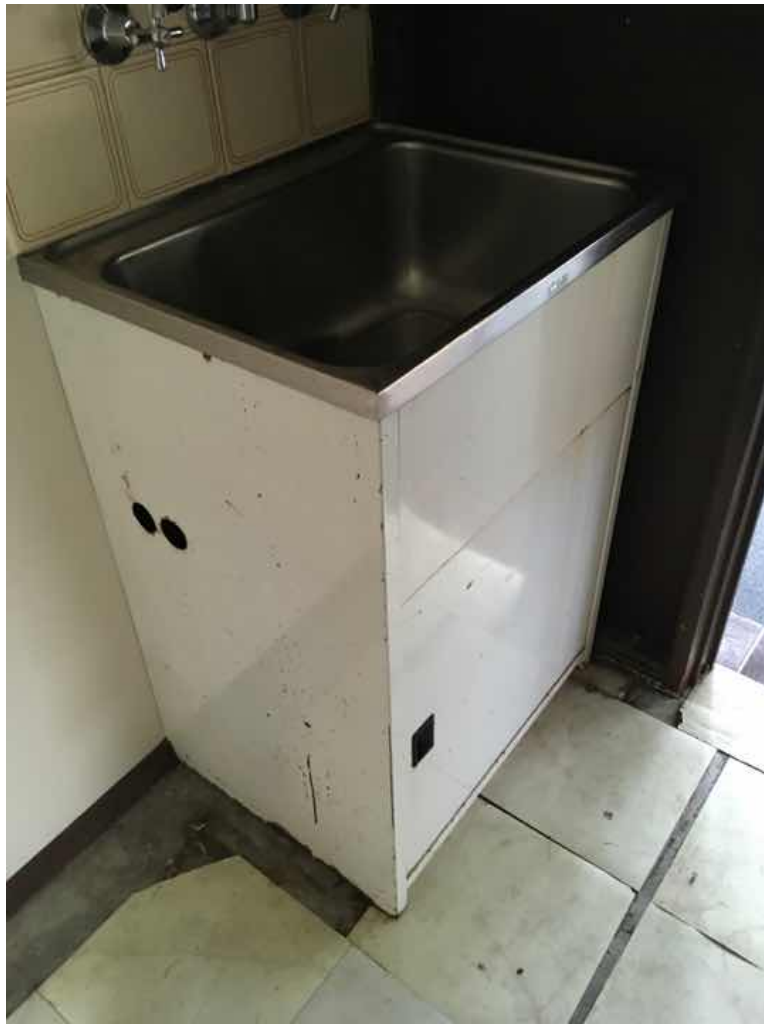
Taps and Tub

Emerging corrosion and surface rust to laundry tub noted. Treat/seal and repaint in the short term. Future replacement is anticipated.

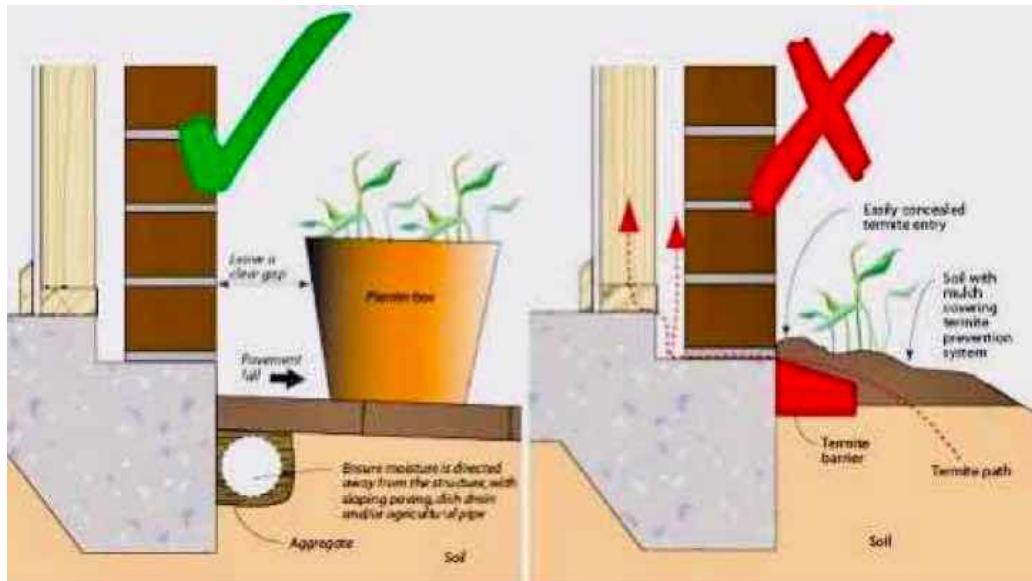
Is the Slab Edge adequately Exposed

Yes in some areas. Ground level needs to be lowered in others.
