Inspection Report

Complete Building Inspection Services

19 Ocean Beach Drive, Shellharbour, NSW, 2529

Pest And Building Inspection

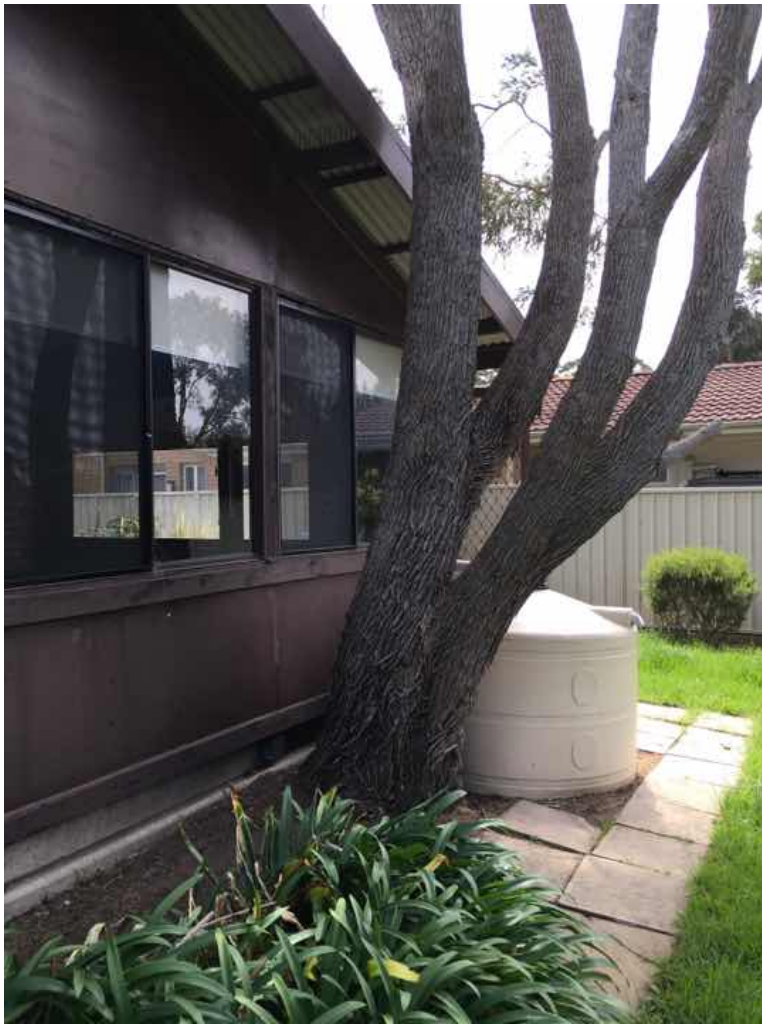
Tree Findings

Trees are close to the dwelling. These currently do not appear to have caused any defects/wall cracking. Recommendations: Trees close to the dwelling have the potential to cause significant cracking in the future. Removal of trees in accordance with an arborists advice and council approval is recommended.

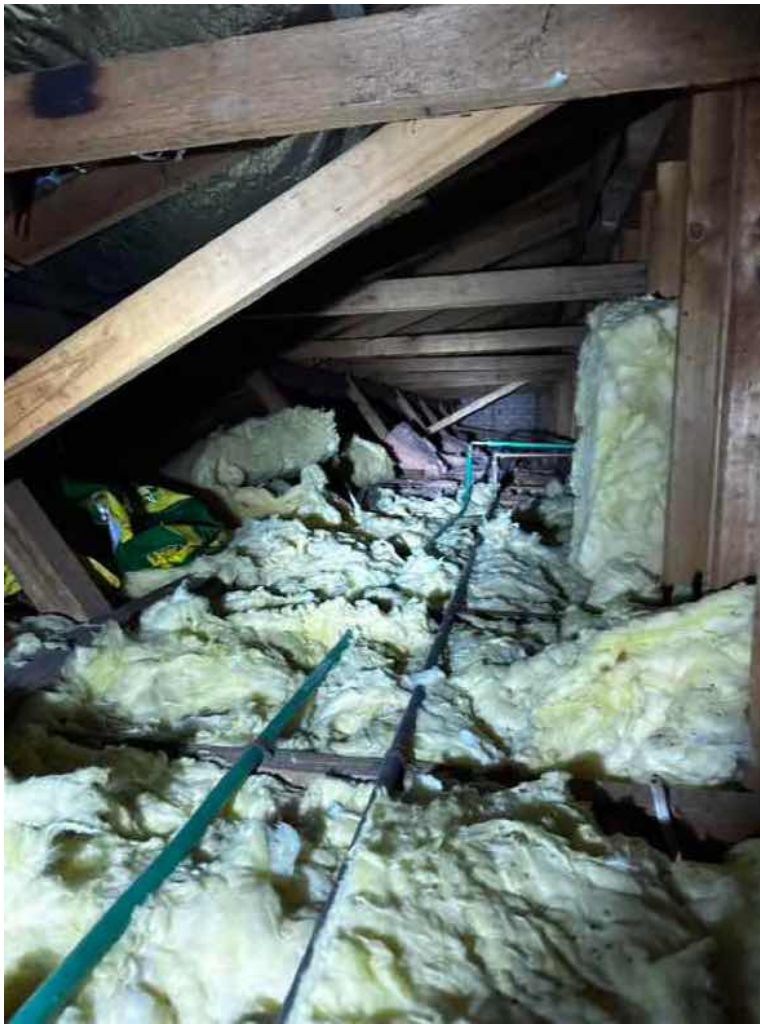
Roof Cladding

The condition of roofing material concealed by sarking material was not able to be assessed at the time of inspection. We are unable to comment on any defects that may exist and are obscured by sarking materials.
